## Wildland Urban Interface Area Inventory Assessment

Chris Gober, Bernalillo County Fire Department  
Frank Barka, Bernalillo County Fire Department  
Karen Lightfoot, New Mexico State Forestry  
July 2002

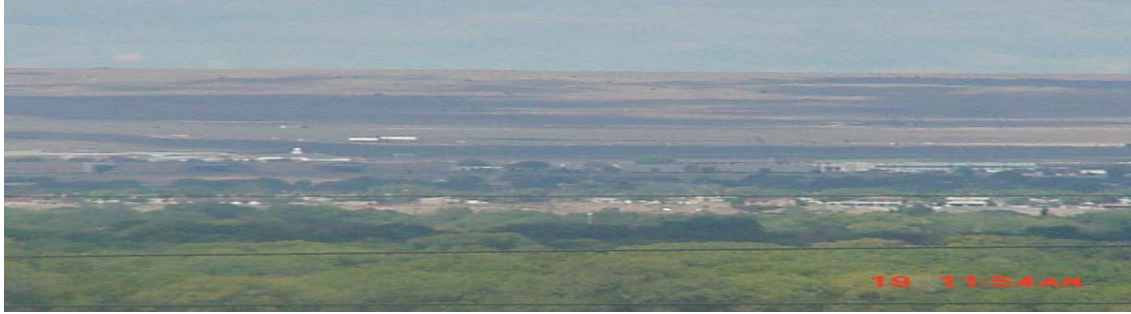
**Descriptive Location:** This area is located off of Isleta Blvd and Blake Rd in the South Valley of Bernalillo County. This area runs along the West Side of the Rio Grande River.

**Special Hazards:** Above Ground electrical lines, propane tanks, narrow winding roads.

**Average Hazard Rating: High** (access, high density, no defensible space, water availability, fire history)

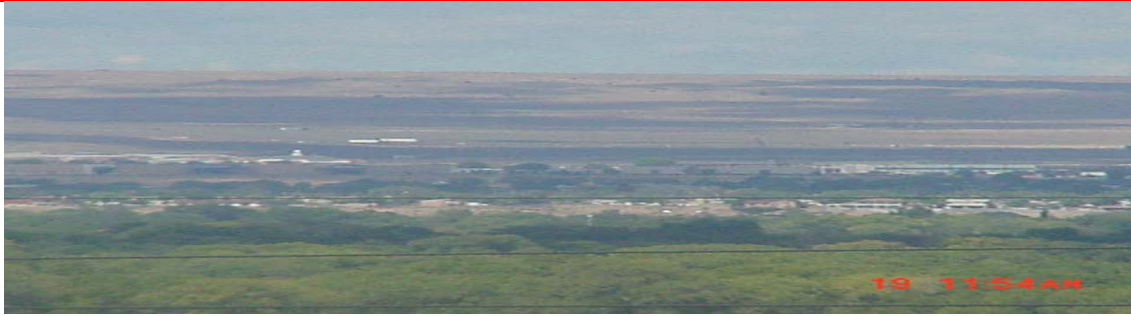
**Descriptive Location:** This area is located off of Isleta Blvd and Bridge Blvd. In the South Valley of Bernalillo County. This area runs along the West Side of the Rio Grande River. There are several crop fields that are on the edge of the Bosque.

**Special Hazards:** Above Ground electrical lines, propane tanks, narrow winding roads.

**Average Hazard Rating: Moderate** (access, high density, no defensible space, water availability, fire history)

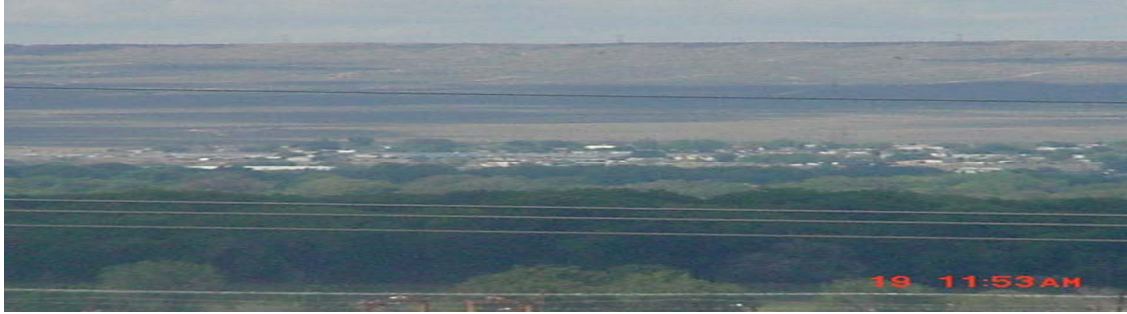
**Descriptive Location:** This area is located off of Isleta Blvd and Rio Bravo Blvd in the South Valley of Bernalillo County. This area runs along the West Side of the Rio Grande River.

**Special Hazards:** Above Ground electrical lines, propane tanks, narrow winding roads.

**Average Hazard Rating:** High, (access, high density, no defensible space, water availability, fire history)

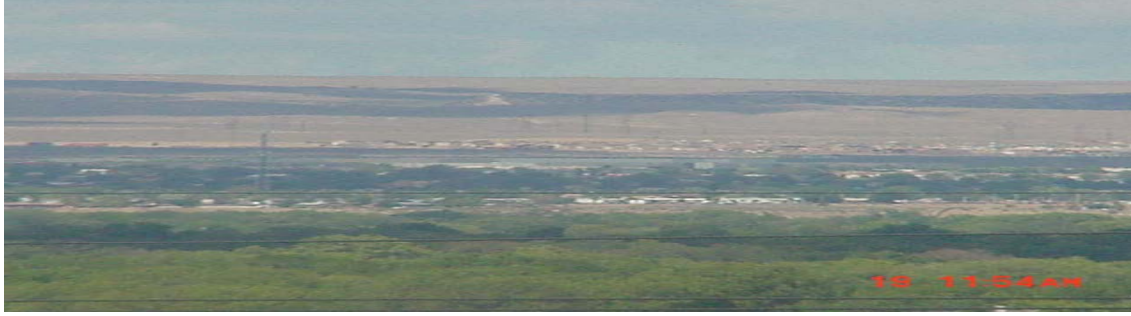
**Descriptive Location:** This area is along 2<sup>nd</sup> Street between Bridge Blvd and Woodward Rd. This area runs along the East Side of the Rio Grande River. There are several crop fields in this area that are on the boundary of the Bosque.

**Special Hazards:** Above Ground electrical lines, propane tanks, narrow winding roads. No defensible space between buildings and Wildland fuels.

**Average Hazard Rating: Moderate** (access, high density, no defensible space, water availability, fire history)

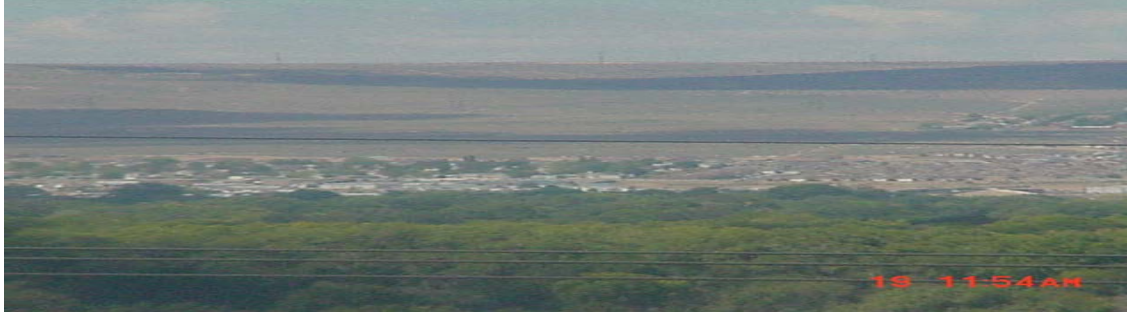
**Descriptive Location:** This area is along 2<sup>nd</sup> Street Between Valley High Rd and Camino Siete Rd. This area runs along the East Side of the Rio Grande River. There are several crop fields in this area that are on the boundary of the Bosque.

**Special Hazards:** Above Ground electrical lines, propane tanks, narrow winding roads. No defensible space between buildings and Wildland fuels.

**Average Hazard Rating: Moderate** (access, high density, no defensible space, water availability, fire history)

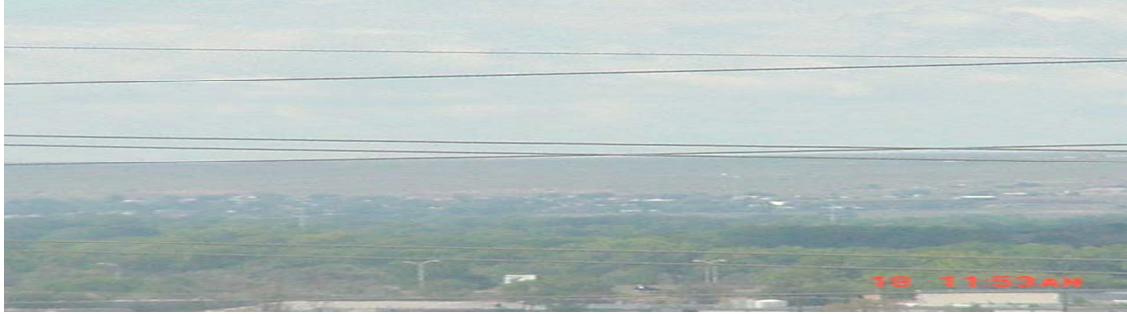
**Descriptive Location:** This area is located off of south Isleta Blvd in the South Valley of Bernalillo County. This area runs along the West Side of the Rio Grande River.

**Special Hazards:** Above Ground electrical lines, propane tanks, narrow winding roads.

**Average Hazard Rating: High** (access, high density, no defensible space, water availability, fire history)

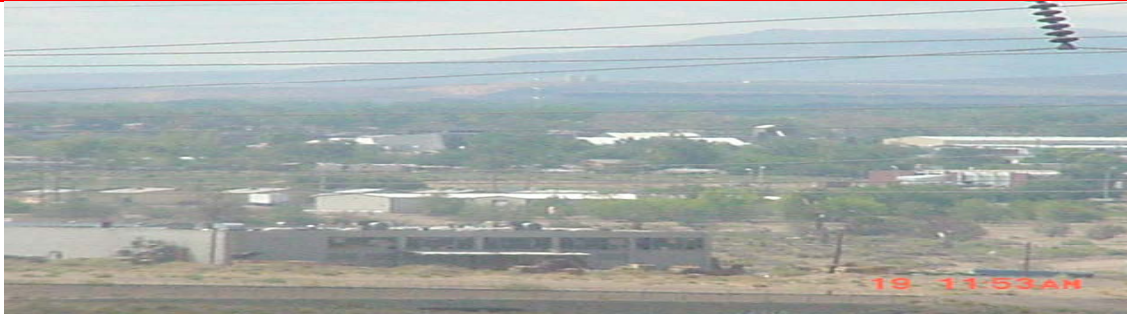
**Descriptive Location:** This area is located South 2<sup>nd</sup> Street in the South Valley of Bernalillo County. This area runs along the East side of the Rio Grande River.

**Special Hazards:** Above Ground electrical lines, propane tanks, narrow winding roads. Water treatment plant with hazardous materials storage.

**Average Hazard Rating: Moderate** (access, high density, no defensible space, water availability, fire history)

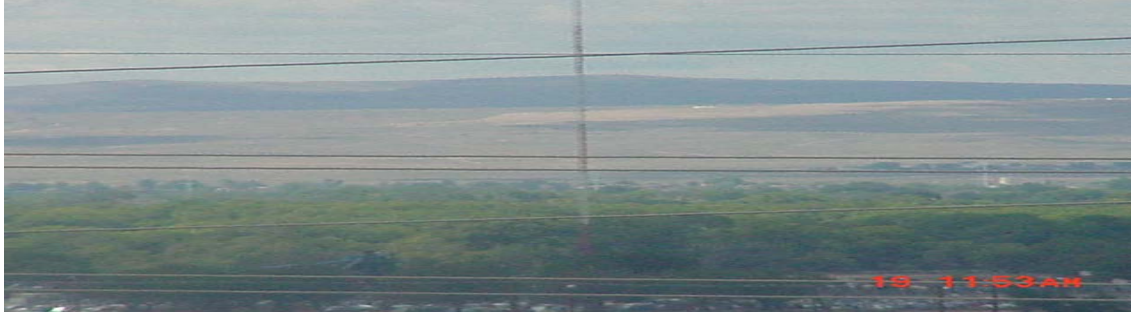
**Descriptive Location:** This area is located off of south Isleta Blvd in the South Valley of Bernalillo County. This area runs along the West Side of the Rio Grande River.

**Special Hazards:** Above Ground electrical lines, propane tanks, narrow winding roads.

**Average Hazard Rating: Moderate** (access, high density, no defensible space, water availability, fire history)

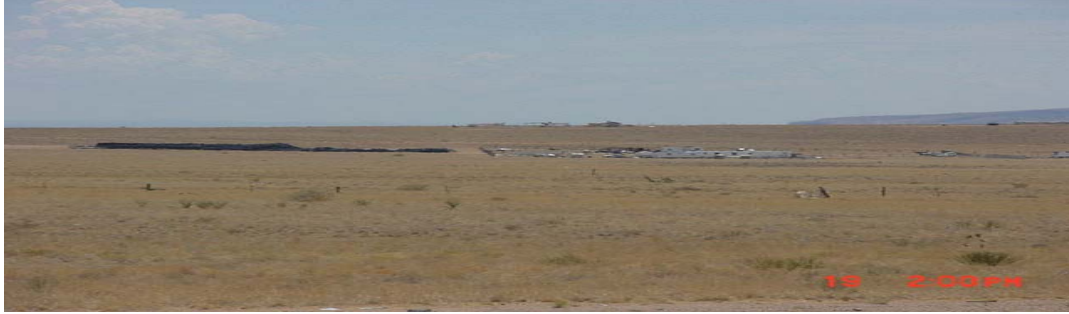
**Descriptive Location:** This area is located at the west end of Pajarito Road from Paseo Del Volcano to the Isleta Indian Reservation (North to South) and Coors to Laguna Indian Reservation (East to West). This area is not developed and most of the residents are homesteading.

**Special Hazards:** high voltage power lines, terrain, building construction no defensible space

**Average Hazard Rating:** Extreme (access, rapid growth, no defensible space, water availability, fire history)

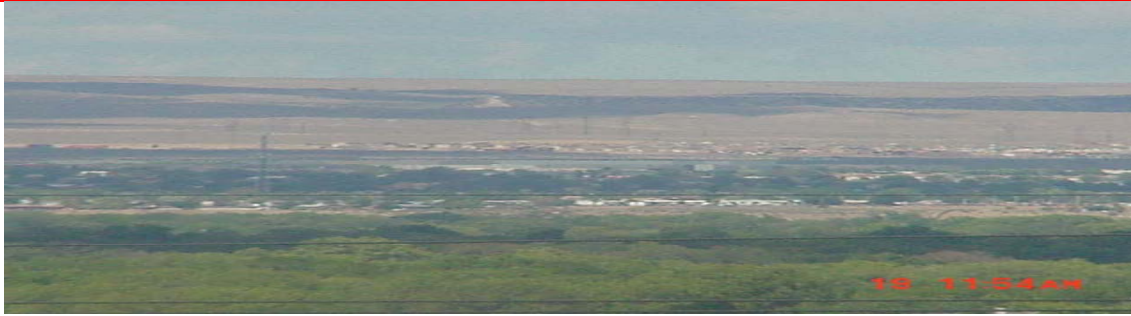
**Descriptive Location:** This area is along 2<sup>nd</sup> Street between Woodward Rd and Rio Bravo Blvd. This area runs along the East Side of the Rio Grande River. There are several crop fields in this area that are on the boundary of the Bosque.

**Special Hazards:** Above Ground electrical lines, propane tanks, narrow winding roads. No defensible space between buildings and Wildland fuels.

**Average Hazard Rating: Moderate** (access, high density, no defensible space, water availability, fire history)

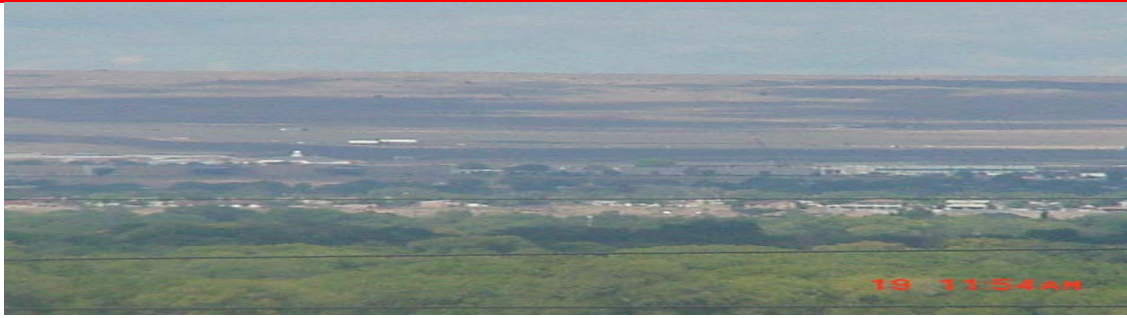
## Alameda 34N 48.0478 106W 43.6452 (T11N R3E sec. 1-18)

**Descriptive Location:** This area is located off of Alameda Blvd in the North Valley of Bernalillo County. This area runs along the East bank of the Rio Grande River. There are large homes, and large agricultural fields in this area. Alameda Blvd. In one of the main access roads to Rio Rancho and the Westside of Albuquerque.

**Special Hazards:** Above Ground electrical lines, narrow winding roads.

**Average Hazard Rating:** Moderate (access, no defensible space, water availability, fire history)

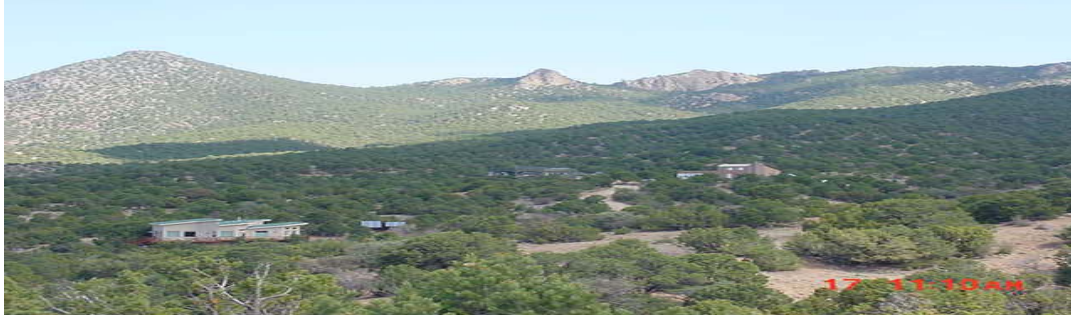
**Descriptive Location:** This subdivision is in Juan Tabo Canyon in Sandoval and Bernalillo Counties, at the end of SR 333. The subdivision is surrounded by U.S Forest Service land. Evergreen Hills is in the Sandia Foothills on the west aspect of the Sandia Mountains.

**Special Hazards:** Road washing out, no electrical utilities in the subdivision. No defensible space around homes and propane tanks.

**Average Hazard Rating: High** (access, slope, distance from fire fighting equipment, and water sources, fire history)

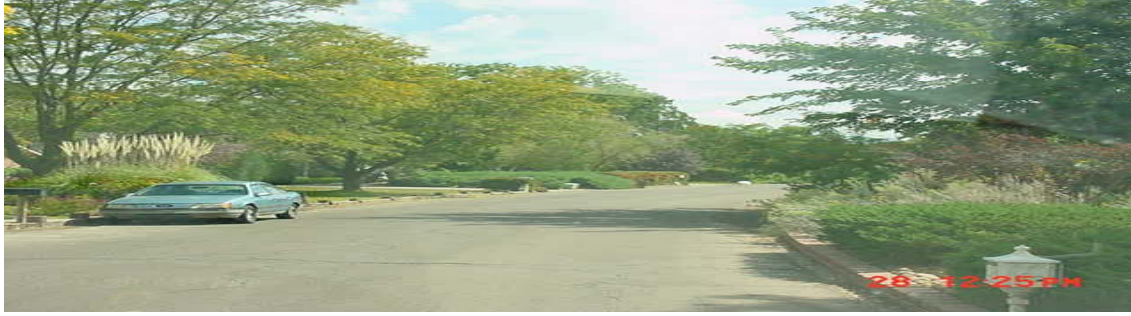
**Descriptive Location:** This area is between 4<sup>th</sup> Street and the Rio Grande River in the City of Albuquerque. This area runs along the East Bank of the Rio Grande River. There are some large homes and agricultural fields in this area.

**Special Hazards:** Above Ground electrical lines, no defensible space

**Average Hazard Rating: Moderate** (access, high density, no defensible space, water availability, fire history)

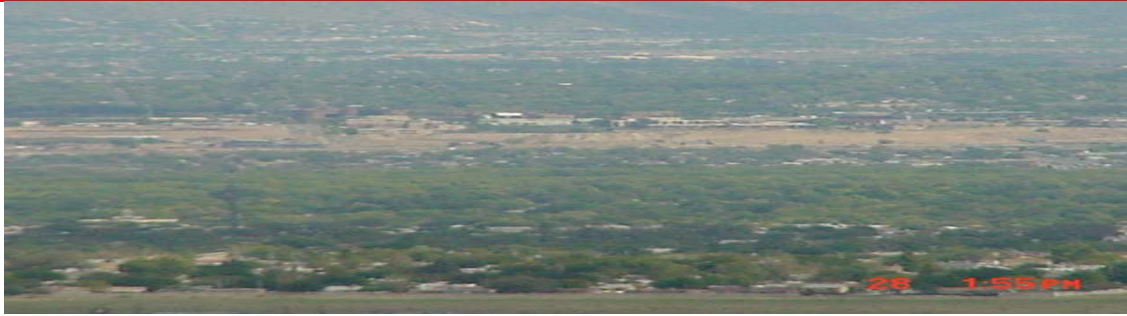
**Descriptive Location:** This area is between 4<sup>th</sup> Street and the Rio Grande River just south of Los Candelarias in the City of Albuquerque. This area runs along the East Bank of the Rio Grande River. There are some large homes and agricultural fields in this area.

**Special Hazards:** Above Ground electrical lines, no defensible space

**Average Hazard Rating:** **Moderate** (access, high density, no defensible space, water availability, fire history)

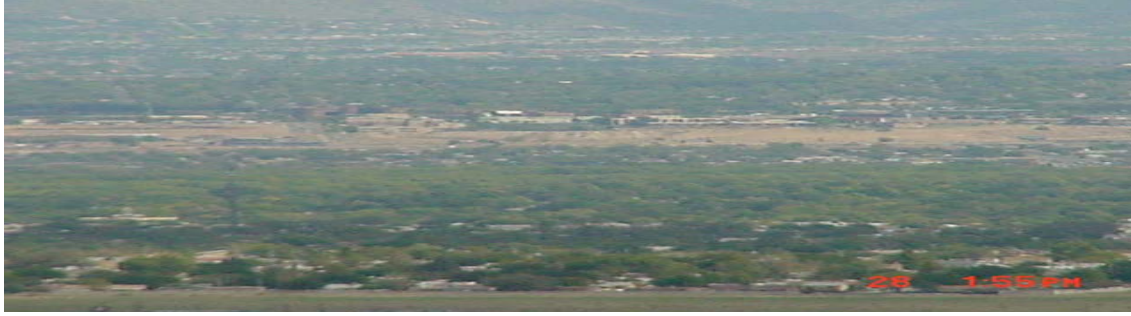
**Descriptive Location:** This area is off of Griegos Rd Between 4<sup>th</sup> Street and the Rio Grande River in the City of Albuquerque. This area runs along the East bank of the Rio Grande River.

**Special Hazards:** Above Ground electrical line, no defensible space

**Average Hazard Rating: Moderate** (access, high density, no defensible space, water availability, fire history)

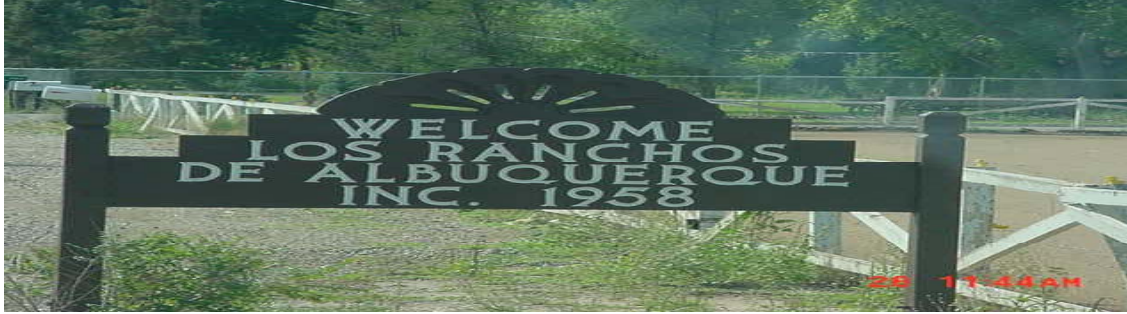
**Descriptive Location:** This area is the North Valley of Bernalillo County and runs along the East bank of the Rio Grande River. There are large homes with a high dollar value, and agricultural fields.

**Special Hazards:** Above Ground electrical lines, high voltage distribution electrical lines, no defensible space

**Average Hazard Rating:** **Moderate** (access, high density, no defensible space, water availability, fire history)

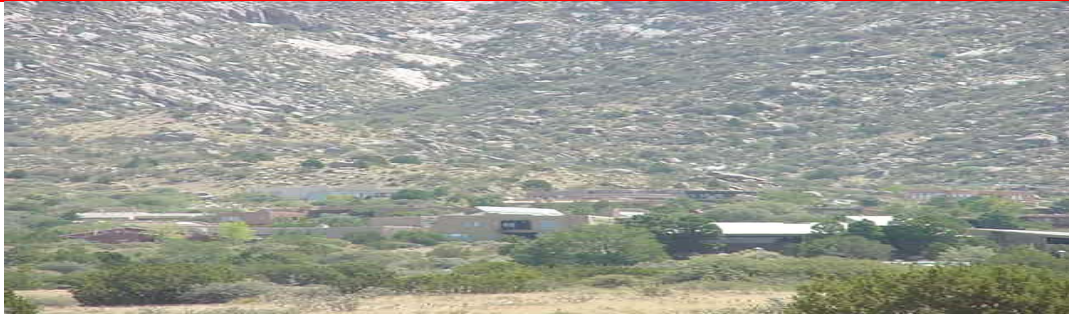
**Descriptive Location:** This subdivision is in La Cueva Canyon in Bernalillo County. U.S. Forest Service and Sandia Indian reservation land surround the subdivision. North Sandia Heights is in the Sandia Foothills on the west aspect of the Sandia Mountains.

Bridges: many homes within the subdivision had bridges incapable of carrying the weight of fire apparatus. None were noted on the main access ways

**Special Hazards:** Exposed propane tanks, unprotected wood decks, homes built on ridge tops, in chimneys and chutes one way in and out of subdivision, no defensible space.

**Average Hazard Rating: High** (access, high density, no defensible space, water availability, fire history)

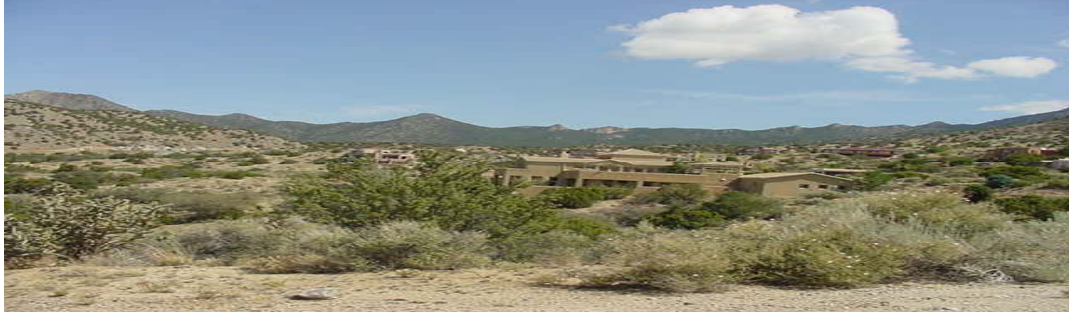
**Descriptive Location:** This subdivision is in Juan Tabo Canyon in Bernalillo County, off of F.R. 333. The subdivision is surrounded by U.S. Forest Service land. Tierra Monte is in the Sandia Foothills on the west aspect of the Sandia Mountains.

Bridges: many homes within the subdivision had bridges incapable of carrying the weight of fire apparatus. None were noted on the main access ways

**Special Hazards:** exposed propane tanks, unprotected wood decks, homes built on ridge tops, in chimneys and chutes one way in and out of subdivision, no defensible space.

**Average Hazard Rating:** High (access, slope, no defensible space, fire history)

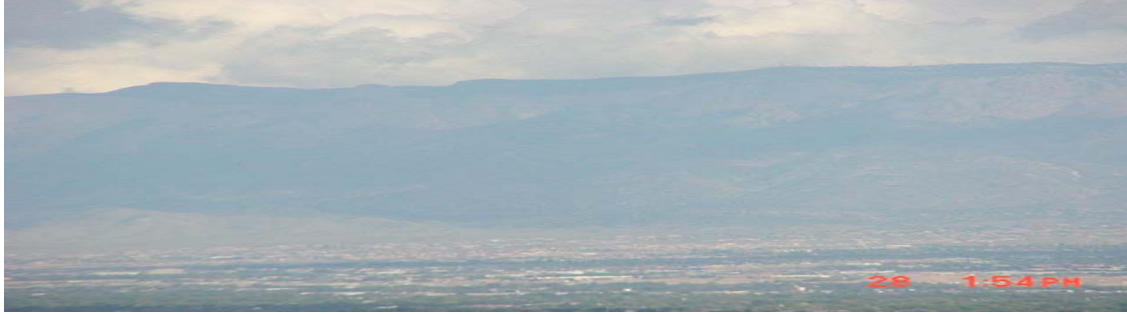
**Descriptive Location:** This area is between Central Ave. and I-40, in the City of Albuquerque. There is a large amount of historical sites, a zoo, and an aquarium in this area. This area runs along the East bank of the Rio Grande River.

**Special Hazards:** Above Ground electrical line, no defensible space, historical areas, zoo, aquarium

**Average Hazard Rating: Moderate** (access, slope, no defensible space, water availability, fire history)

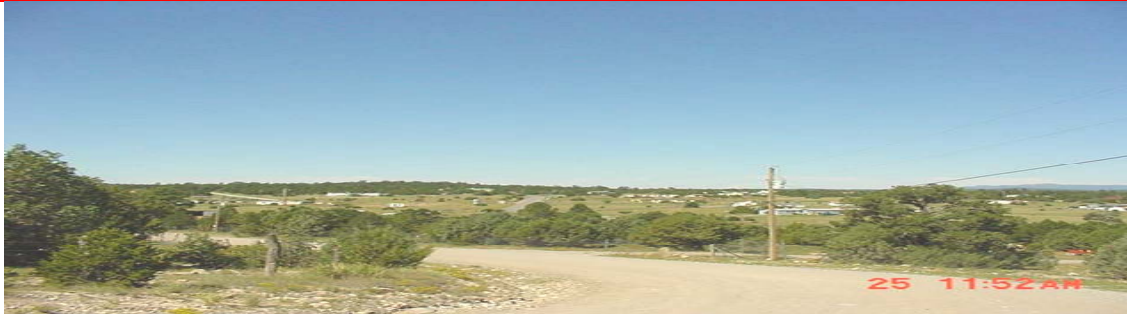
**Descriptive Location:** This area is off of Martinez Rd and Hwy 217. This area is on the county line Between Bernalillo County and Tarrant County. Parts of this area are closer to Tarrant County fire equipment then they are Bernalillo County fire equipment. This area is surrounded by state and private land. Homes in this area are built on all aspects of slopes and range from mid-slope to the top of the slope.

**Special Hazards:** Above Ground electrical lines, narrow winding roads. No defensible space, house built mid-slope, at the top of slopes, in chimneys, and in chutes. Long turn around time for water tenders.

**Average Hazard Rating: High** (access, slope, no defensible space, building materials water availability, fire history)

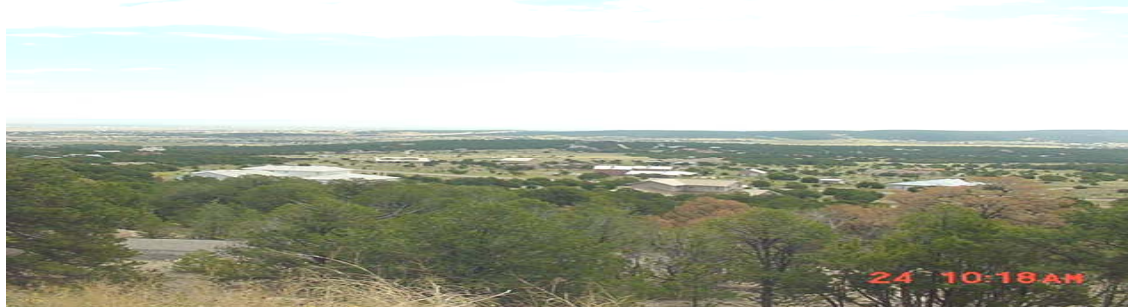
**Descriptive Location:** Access to this area is various roads off of Hwy 66 and Barton Rd. This area is located at the county line between Bernalillo County and Sante Fe County. State and private lands surround this area. Houses in this area are built at ridge tops, mid-slope, in chimneys, and in chutes.

**Special Hazards:** Above Ground electrical lines, narrow winding roads. No defensible space, house built mid-slope, at the top of slopes, in chimneys, and in chutes.

**Average Hazard Rating: High** (access, slope, no defensible space, building materials, water availability, fire history)

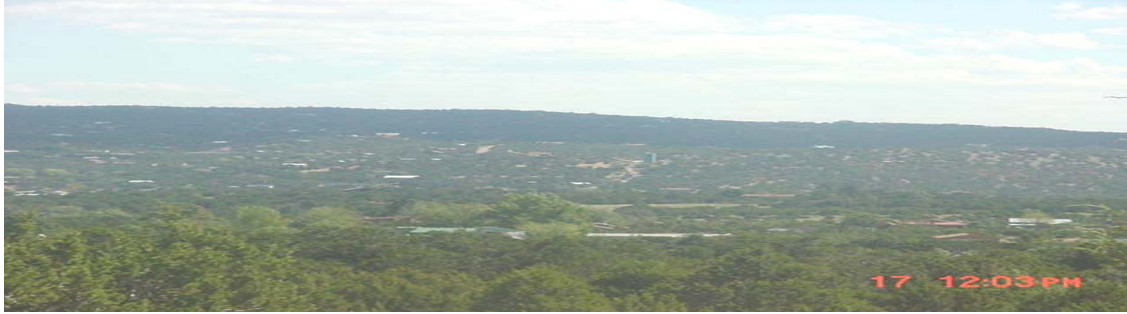
**Descriptive Location:** This area is located off of North Highway 14 in the Canoncito Canyon. North Highway 14 is a four lane paved highway. Forest Service, State and private land surround this area. There are some Archaeological sites in this area also.

**Special Hazards:** Above Ground electrical lines, unprotected wood decks, homes built on ridge tops, in chimneys and chutes one way in and out of subdivisions, no defensible space.

**Average Hazard Rating: High** (access, slope, no defensible space, building materials, water availability, fire history)

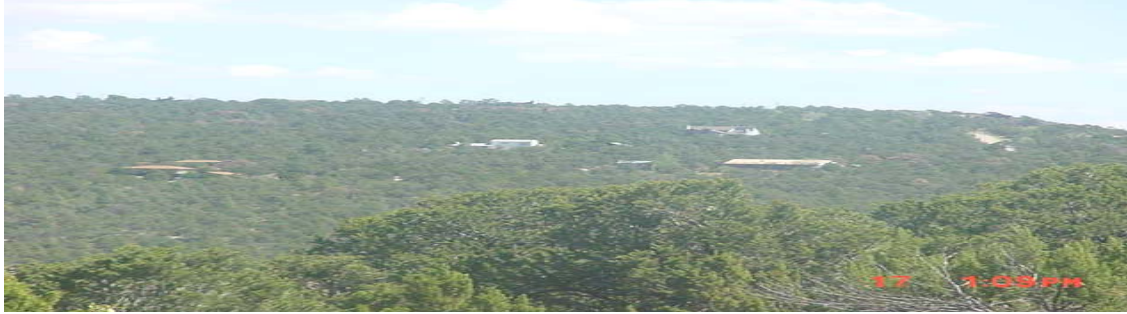
**Descriptive Location:** This area is off of North Highway 14 between Lorenzo and Hondo Canyons. This area is 1 mile south of Forest Park. Casa Loma is on the boundary of the Sandia Mountain Wilderness.

**Special Hazards:** above ground utilities, Wilderness area to the west

**Average Hazard Rating: High** (access, slope, no defensible space, building materials, water availability, fire history)

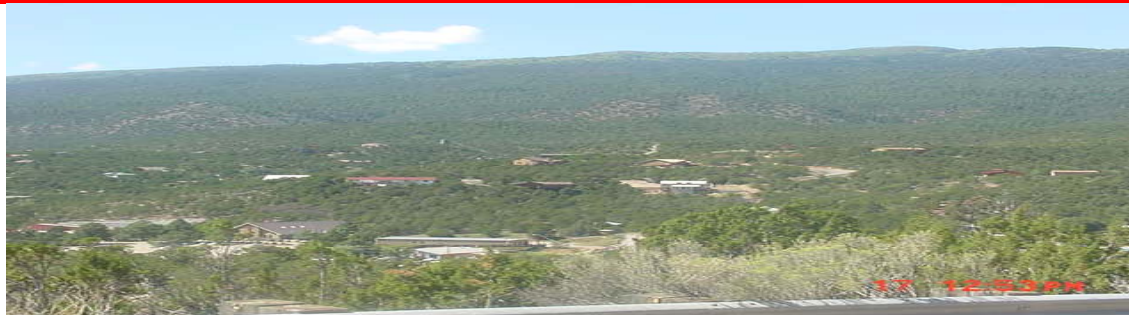
**Descriptive Location:** This area is off of North Highway 14 two miles north of I-40. There is a subdivision in this area (Sierra Vista). There is also a mobile home park in this area.

**Special Hazards:** Above Ground electrical lines, unprotected wood decks, homes built on ridge tops, in chimneys and chutes one way in and out of subdivisions, no defensible space.

**Average Hazard Rating: High** (access, slope, no defensible space, building materials, water availability, fire history)

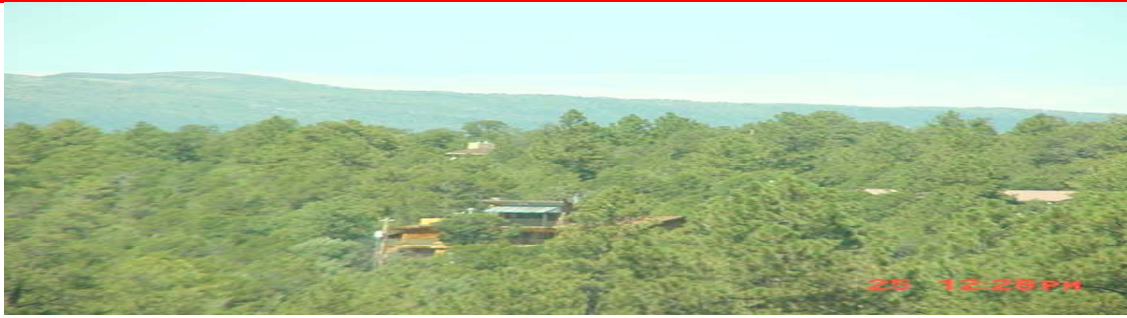
**Descriptive Location:** This area is off of Hwy 337 in the Cedro Canyon. This area is surrounded by U.S. Forest Service land. There is only one in and out of this area, which is Hwy 337, which also serves approximately 20,000 residents in the south portion of Bernalillo County.

**Special Hazards:** Above Ground electrical lines, narrow winding roads. No defensible space, house built mid-slope, at the top of slopes, in chimneys, and in chutes. Long turn around time for water tenders.

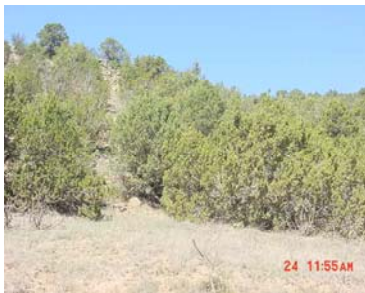
**Vegetation Fuels:** The fuels in this area are typical of the lower elevation, which consist of pinyon-juniper, grasses, sagebrush, and scrub oak. The fuels in this area are drought stricken, diseased, or insect infested.

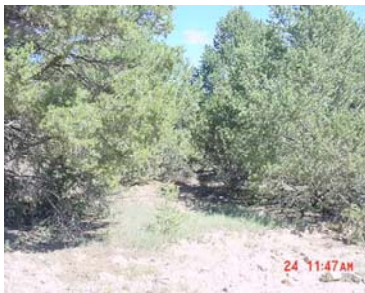
**Vegetation Fuels:** The fuels in this area are typical of the lower elevation, which consist of Pinyon-Juniper, grasses, sagebrush, and scrub oak. The fuels in this area are drought stricken, diseased, or insect infested.
